Experiences and challenges faced during a new service roll out

Joyce Joy, Cormac McGrath & Adam Workman
Regional Medical Physics Service, Belfast Health & Social Care Trust, NI

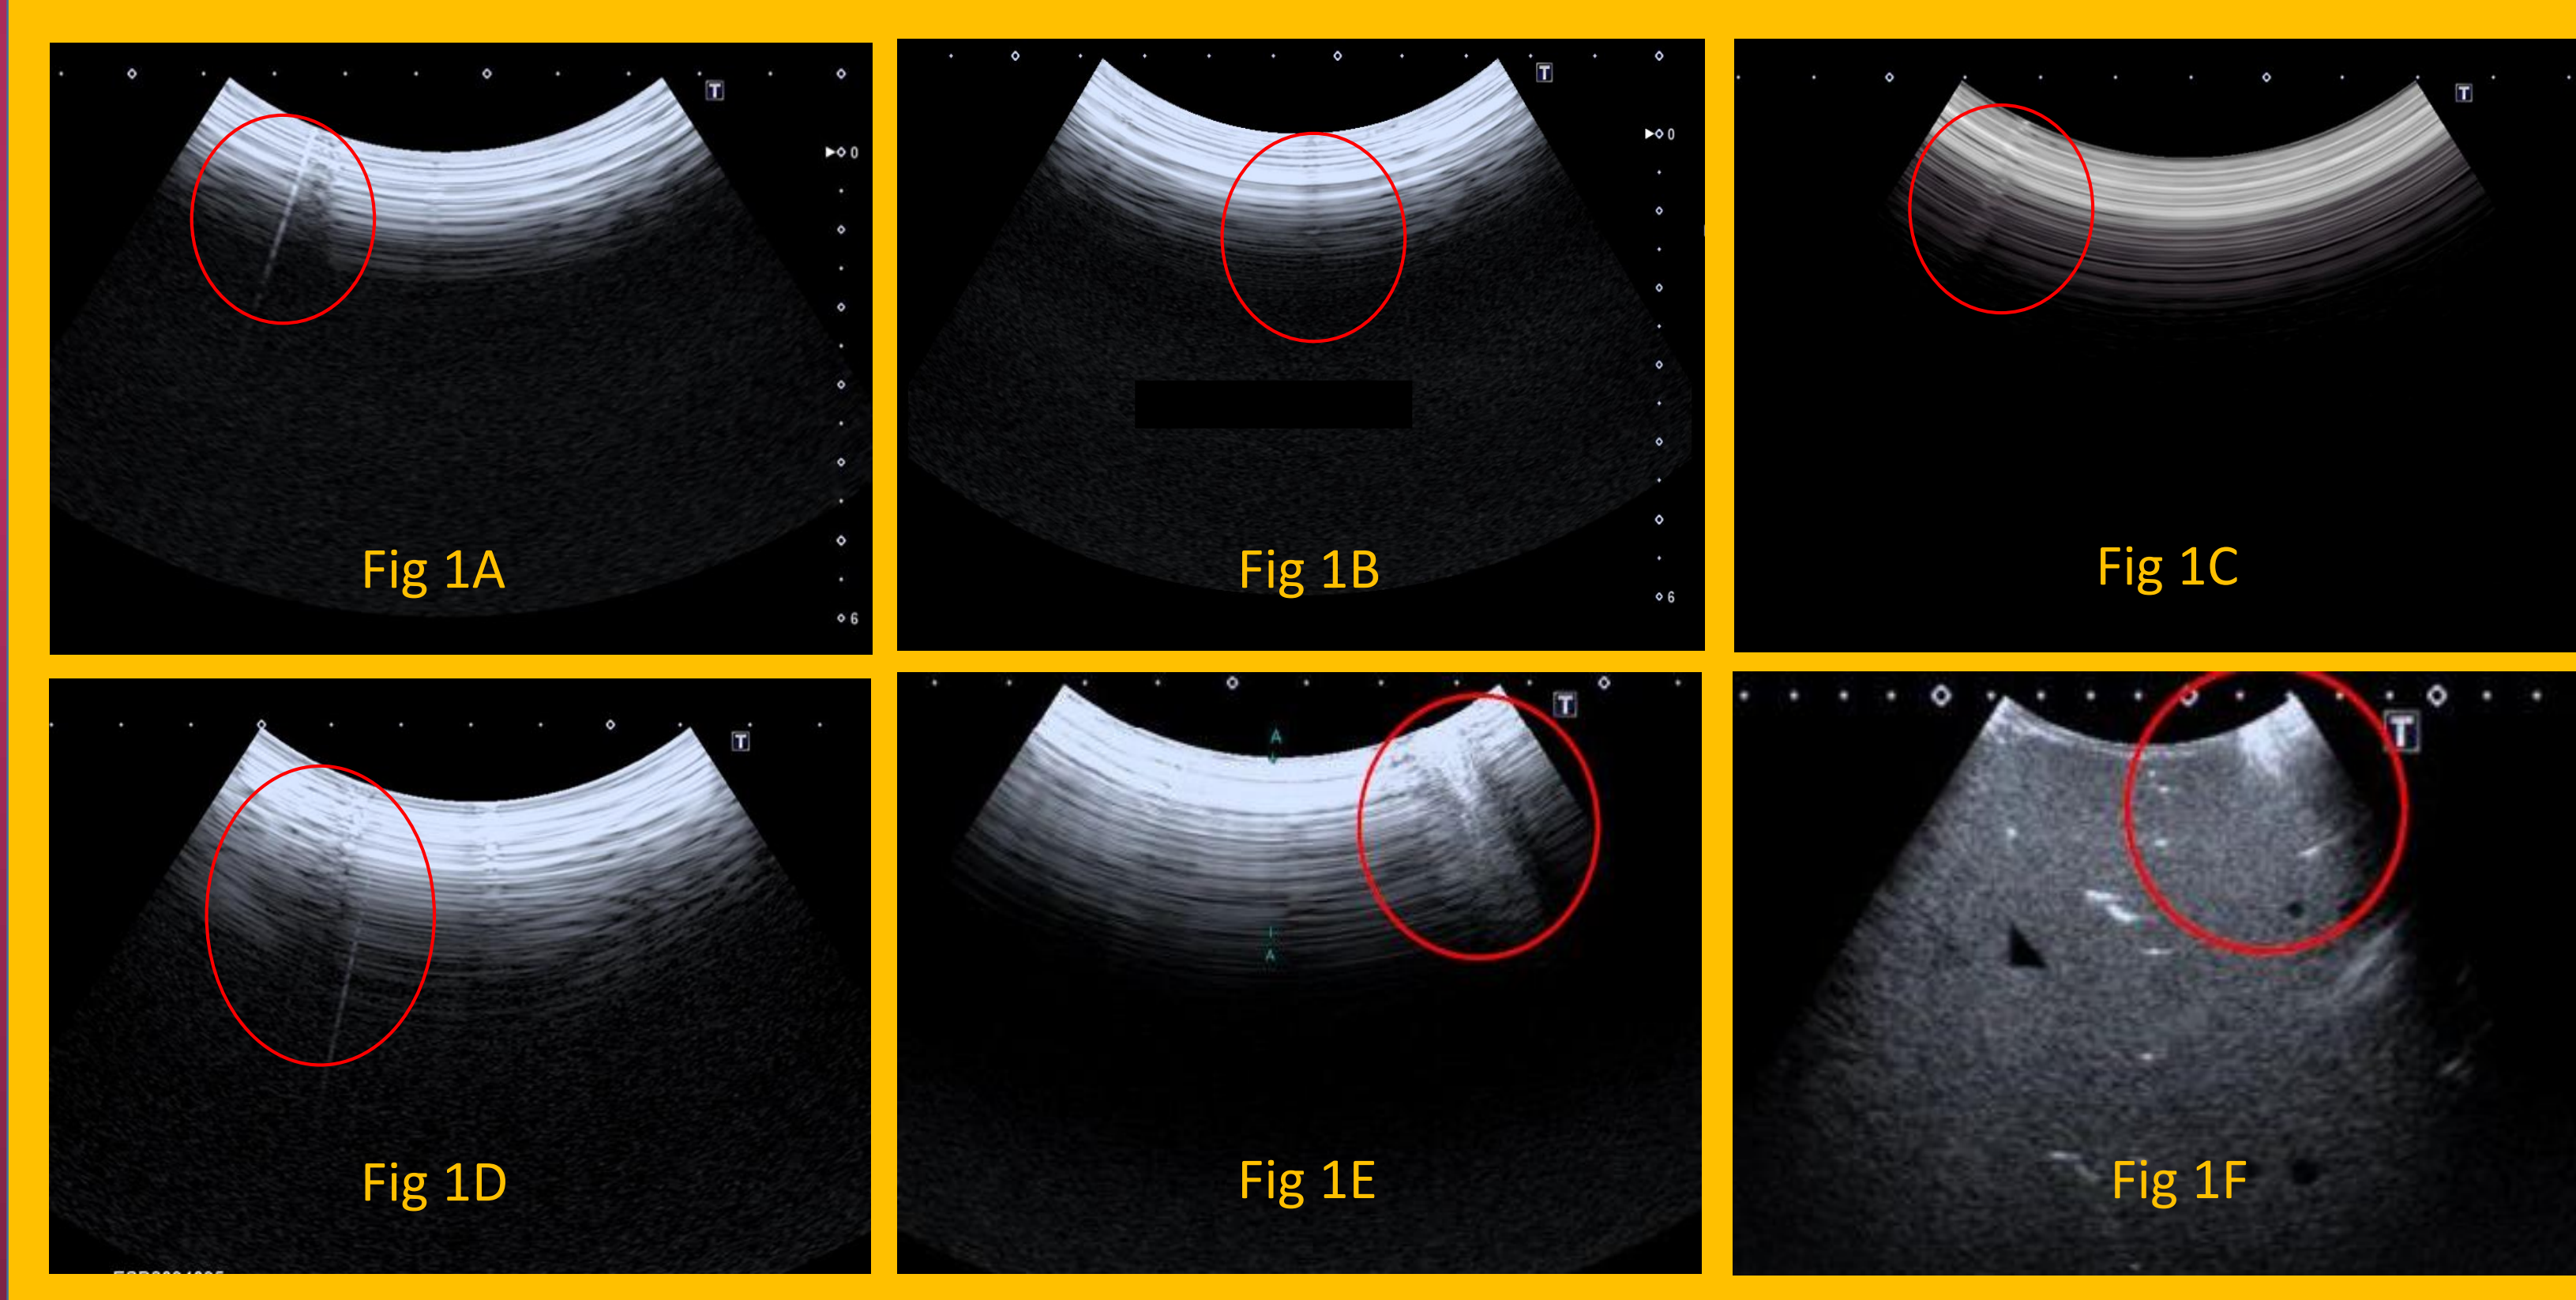
Figure:1A-1F 70% (7/10) of a particular type of probe from Manufacturer A were found to have major faults. Cable fault, shattered crystal and increased number of drop outs were some faults repeatedly noticed. Manufacturer replaced all faulty probes

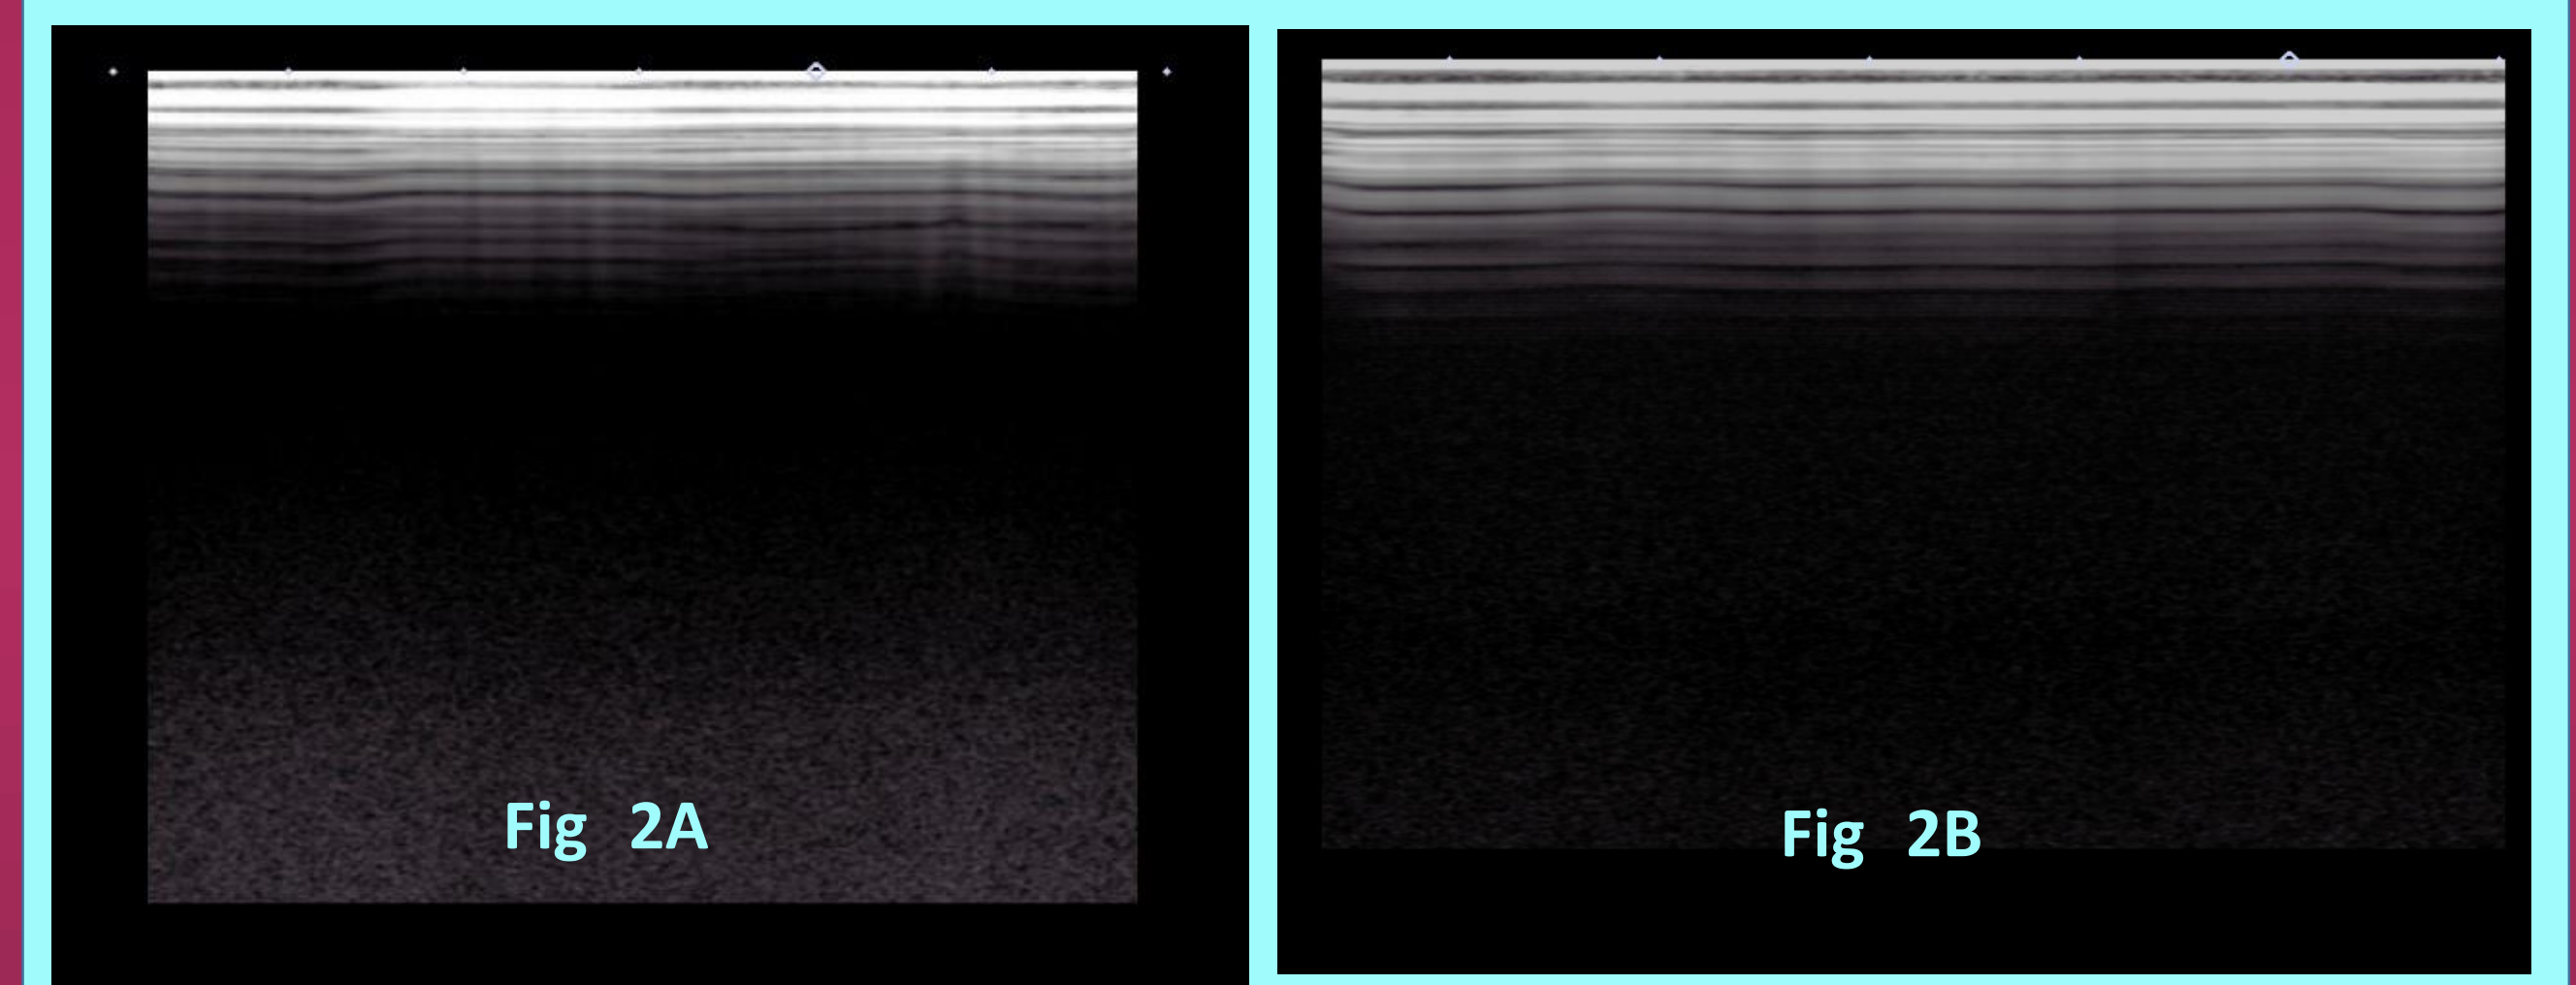
Figure:2A-2B: Variation in lens thickness noticed on 2 occasions on the same type of probes from Manufacturer A in BSP department. Manufacturer described this as a ghosting artefact and upon further request electronic testing was conducted. Results revealed faults with Probe A (replaced). Probe B had a few elements with weaker sensitivity, but was still within acceptable tolerance limits, and was not replaced.

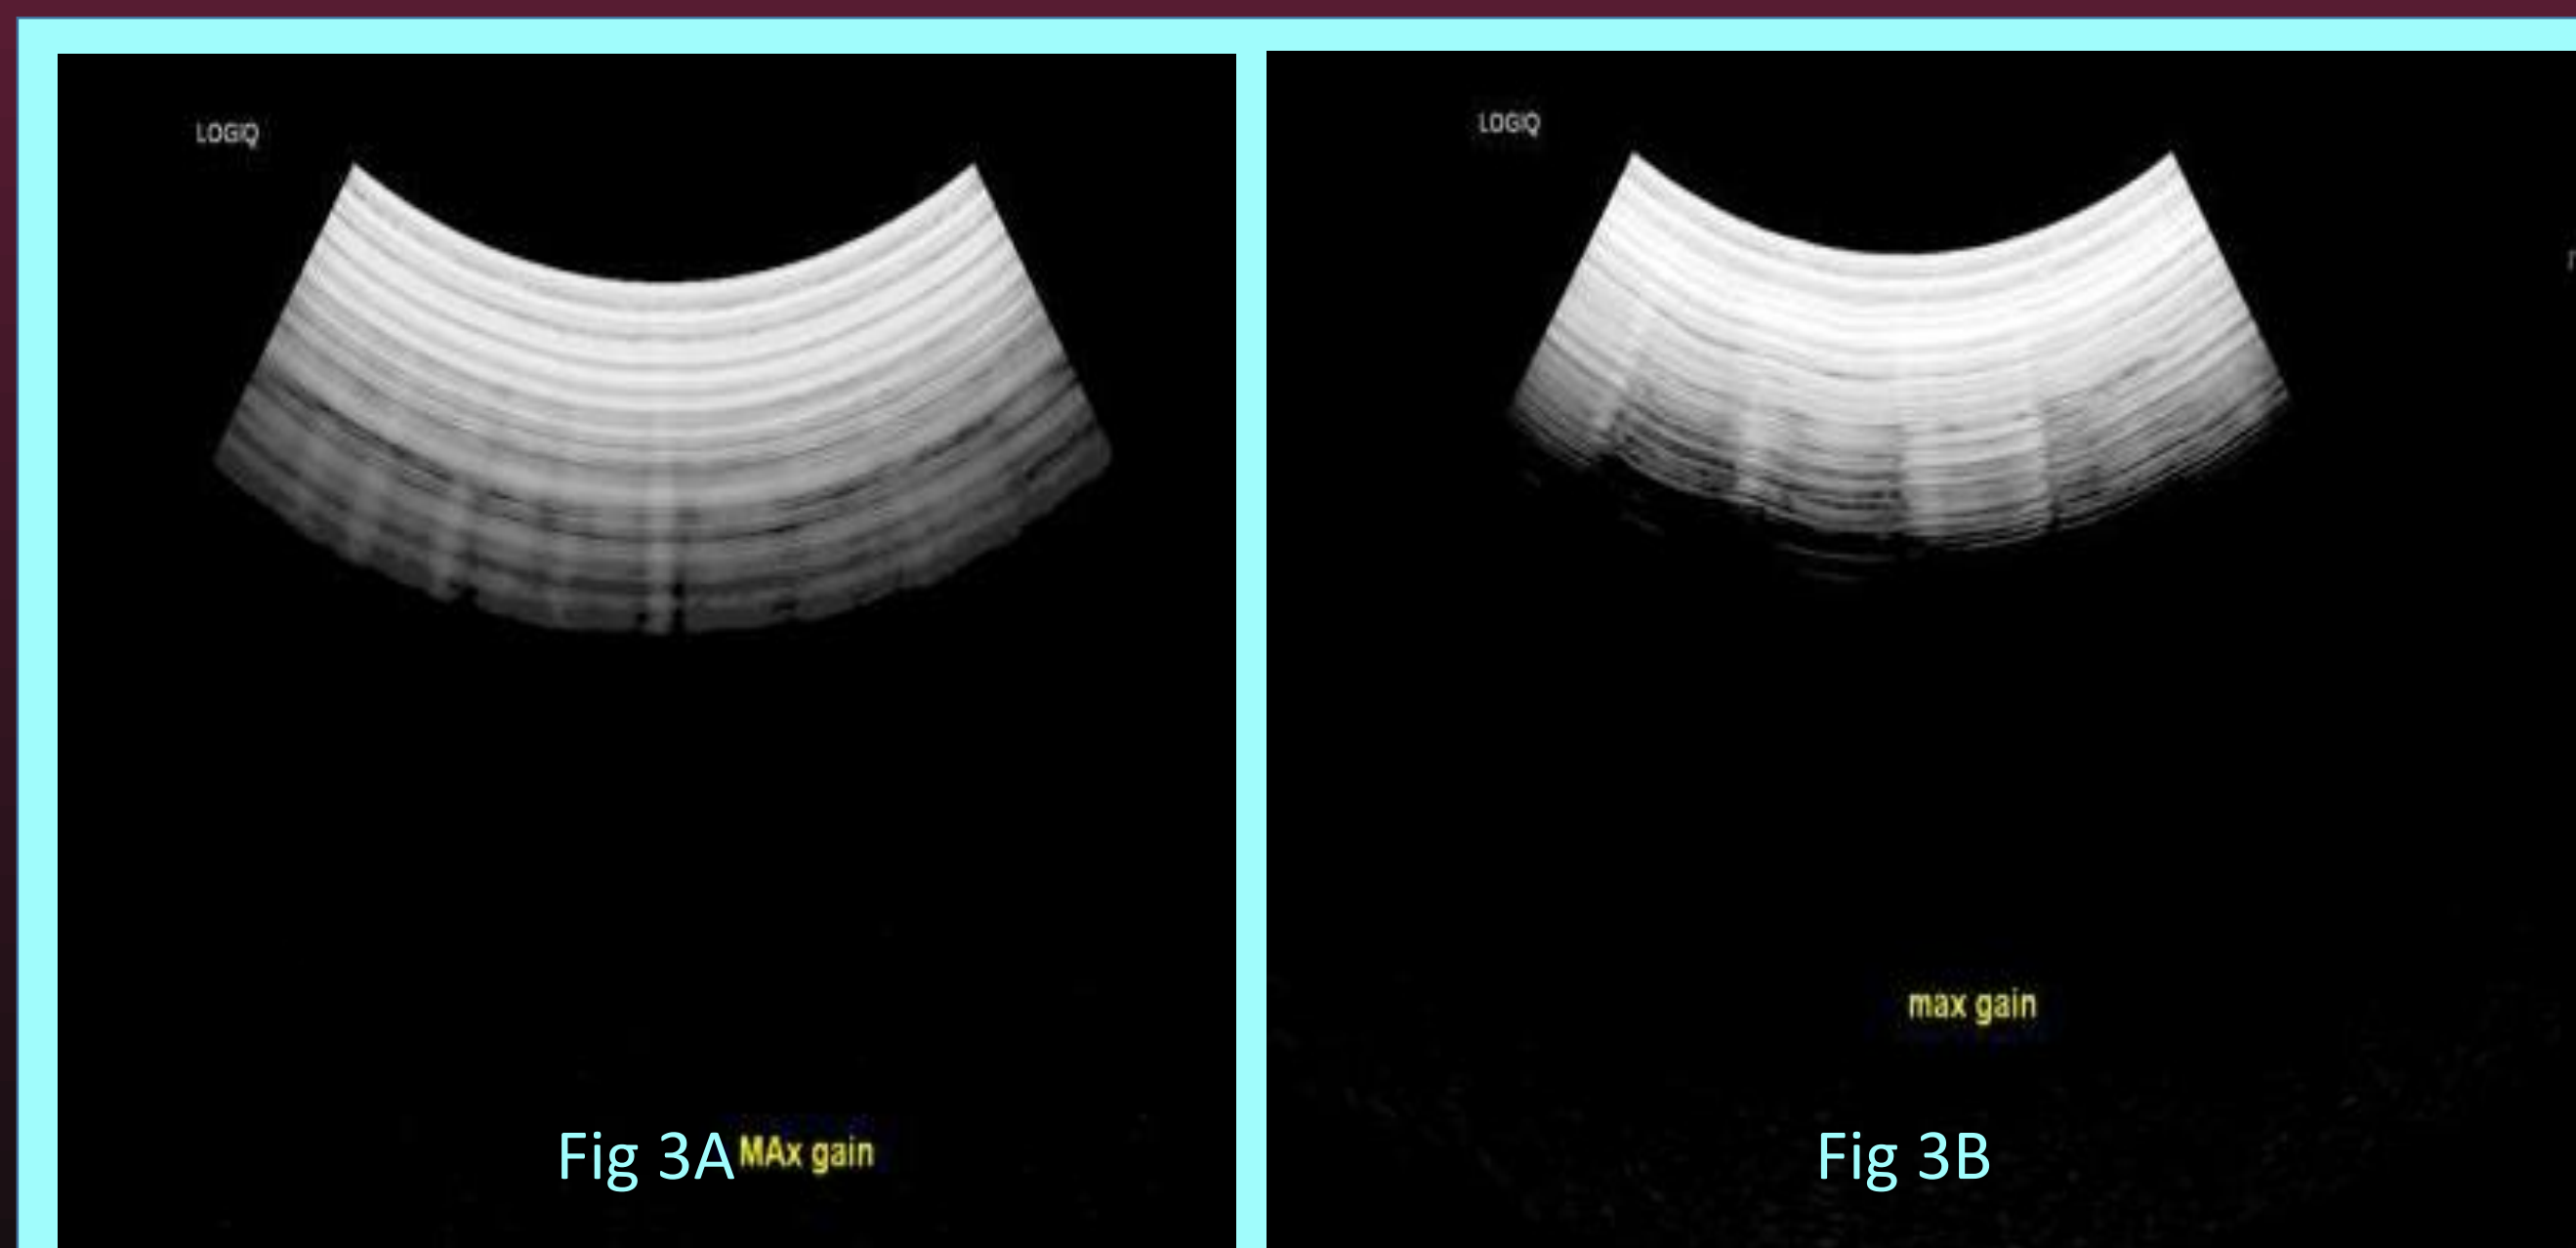
Figure: 3A-3B: Non-uniformities in reverberations and "washed out" appearance of images noted with one Probe from Manufacturer B. Probe was replaced, but fault was non-diagnosed.

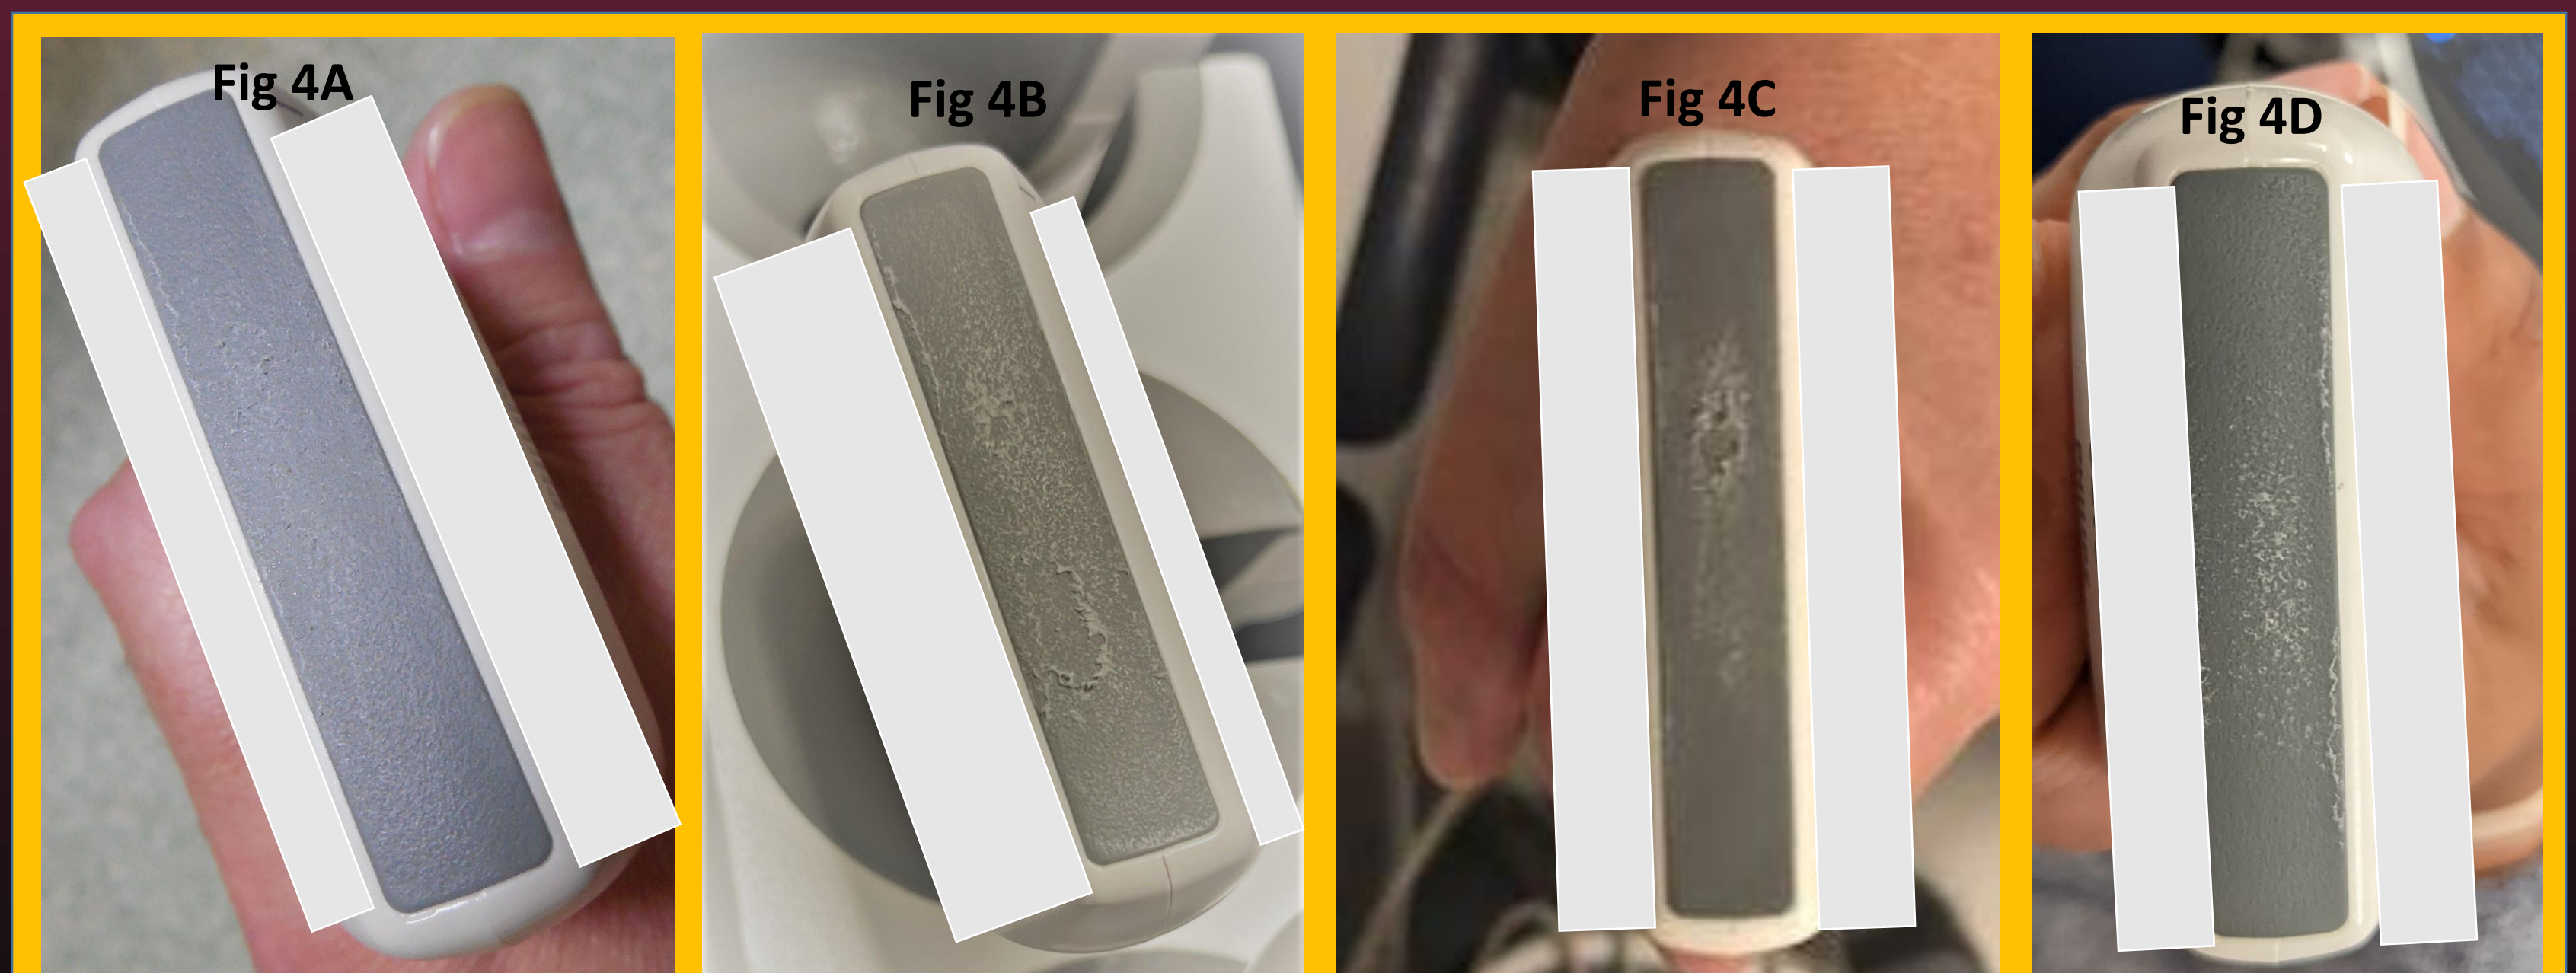
Figure: 4A-4D: 4 probes of a specific model from Manufacturer C were rejected due to similar damage to the surface coating making it impossible to clean adequately, hence presenting a cross contamination risk. All 4 probes replaced.

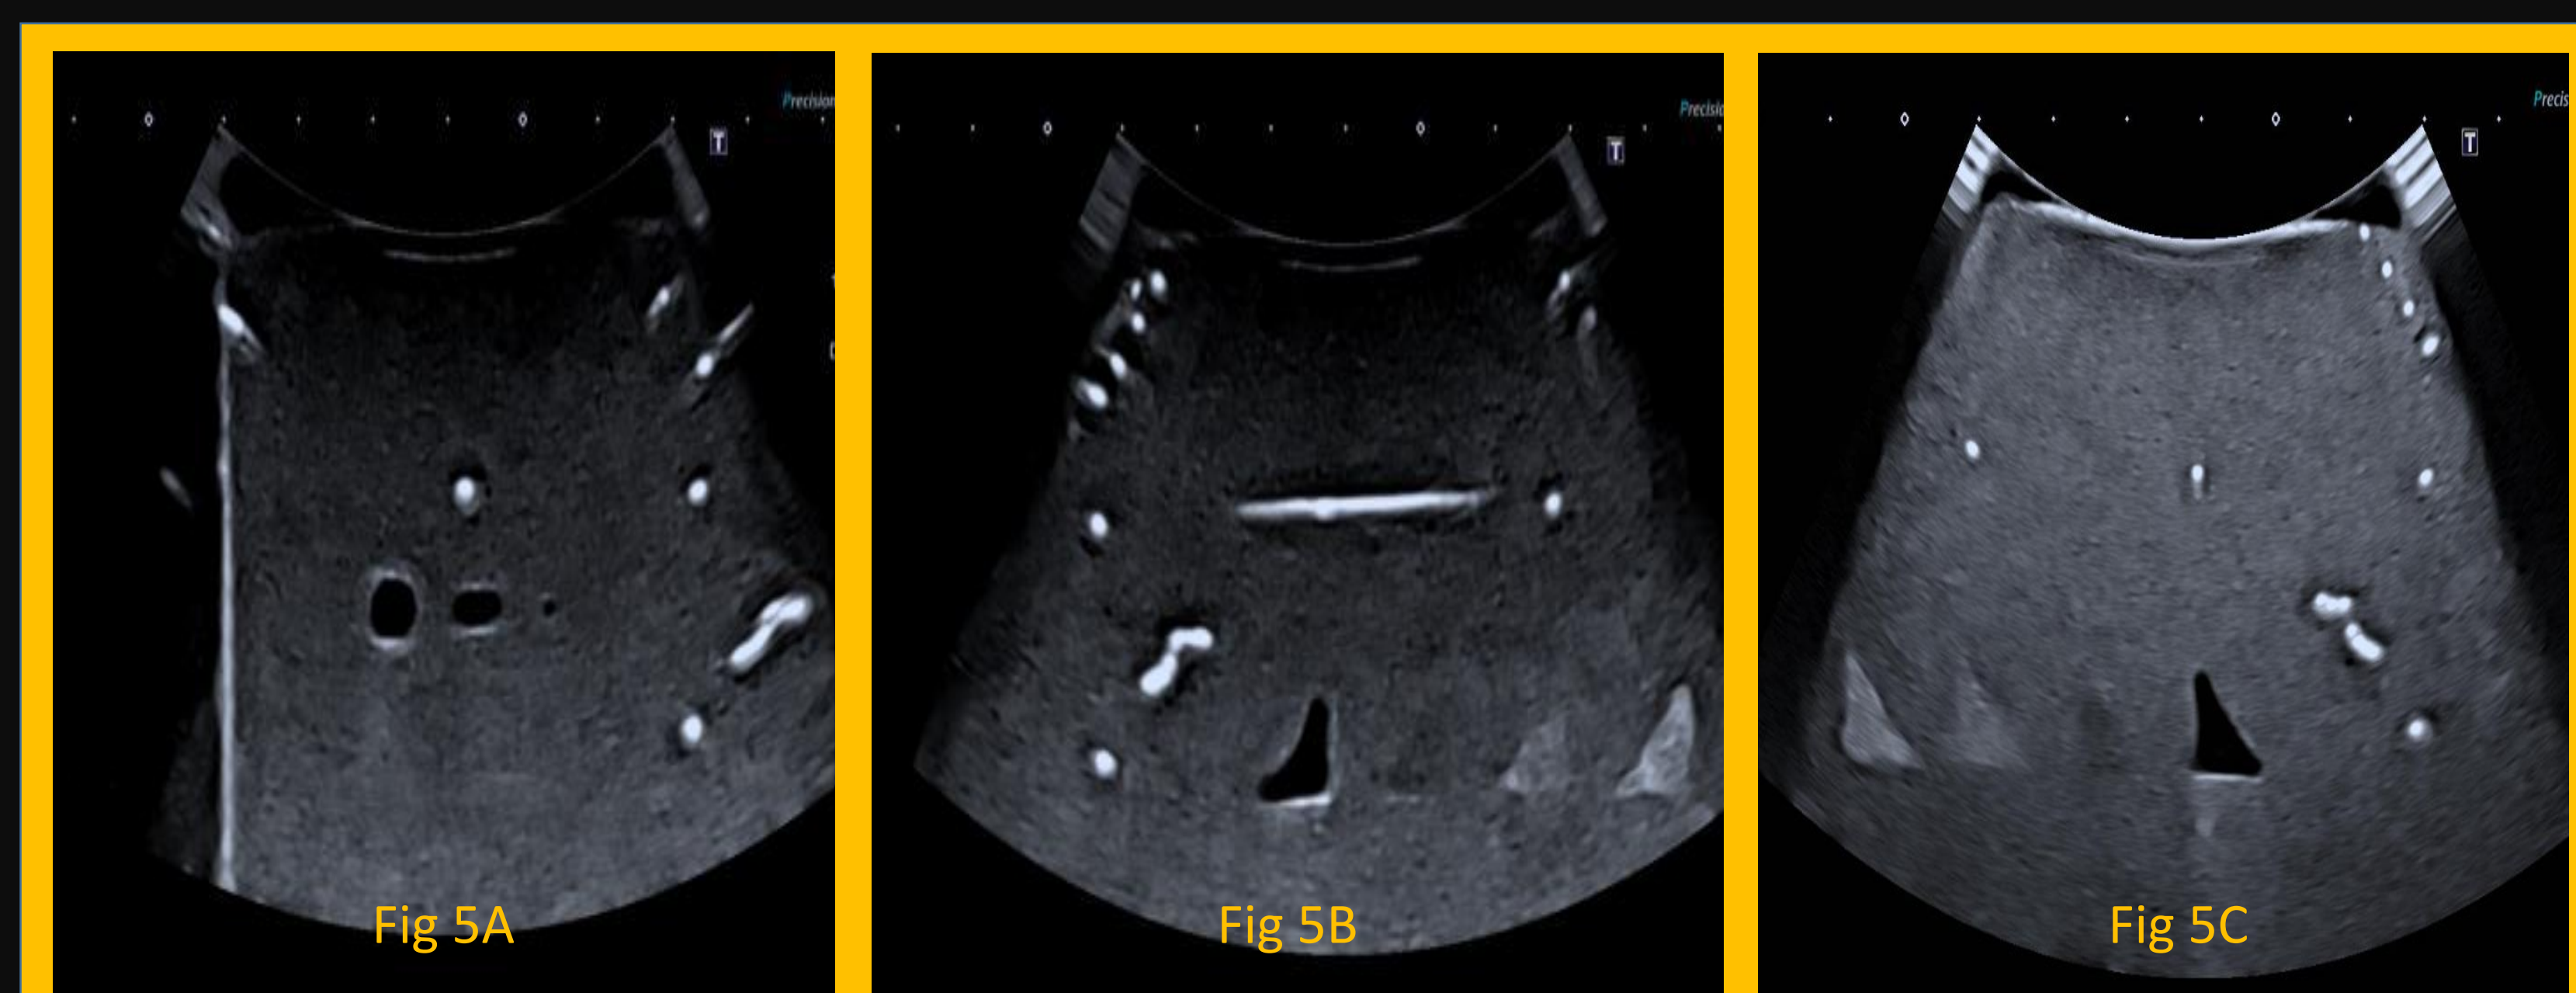
Figure: 5A-5C: Image distortion effect with speckle reduction imaging ON was noted on 2 probes of same model from Manufacturer A. Manufacturer quoted this as "a non-isotropic behaviour in the higher value speckle reduction algorithm with the tendency to "connect speckles" stronger in lateral than in axial direction. The bias this non-isotropic Imaging is introducing is within the tolerance of the claimed measurement accuracy for the ultrasound system". Probe not replaced.
